J.C. BACON DAM

NDI I.D. NO: PA-260

PHASE I INSPECTION REPORT  
NATIONAL DAM INSPECTION PROGRAM

MAY 1979

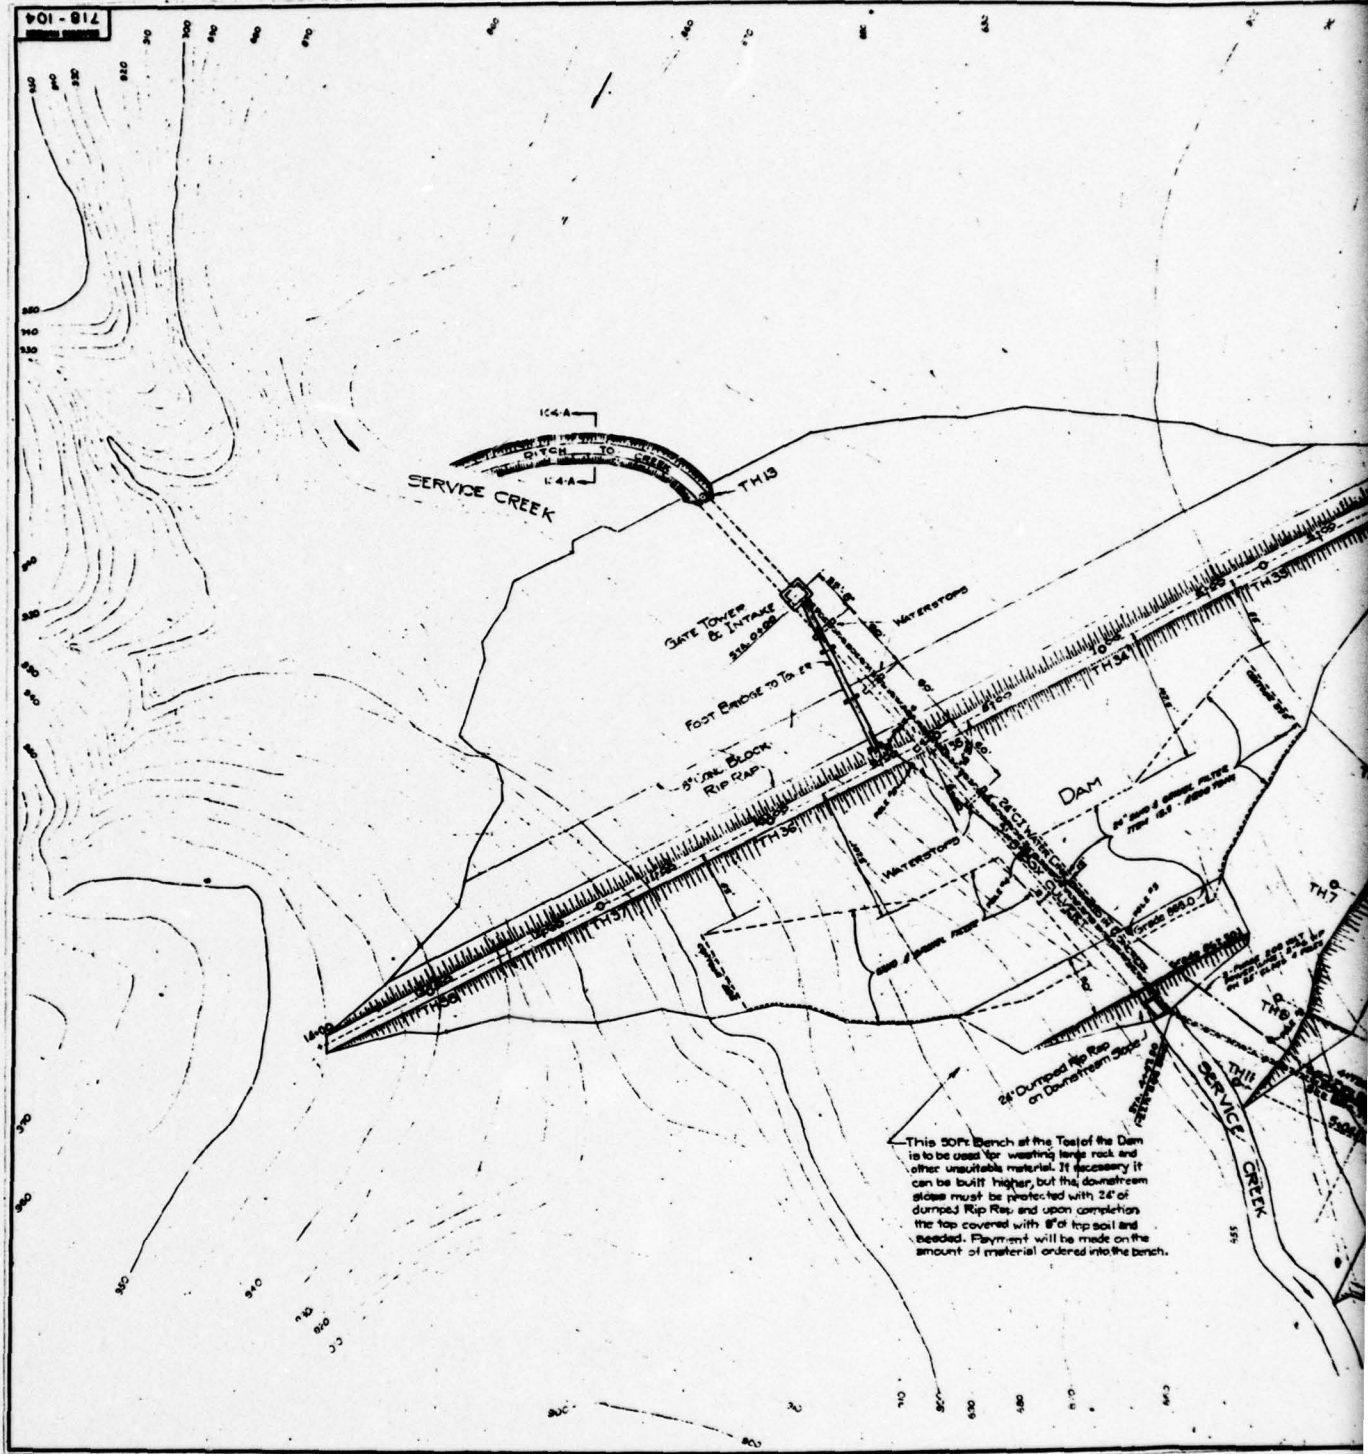
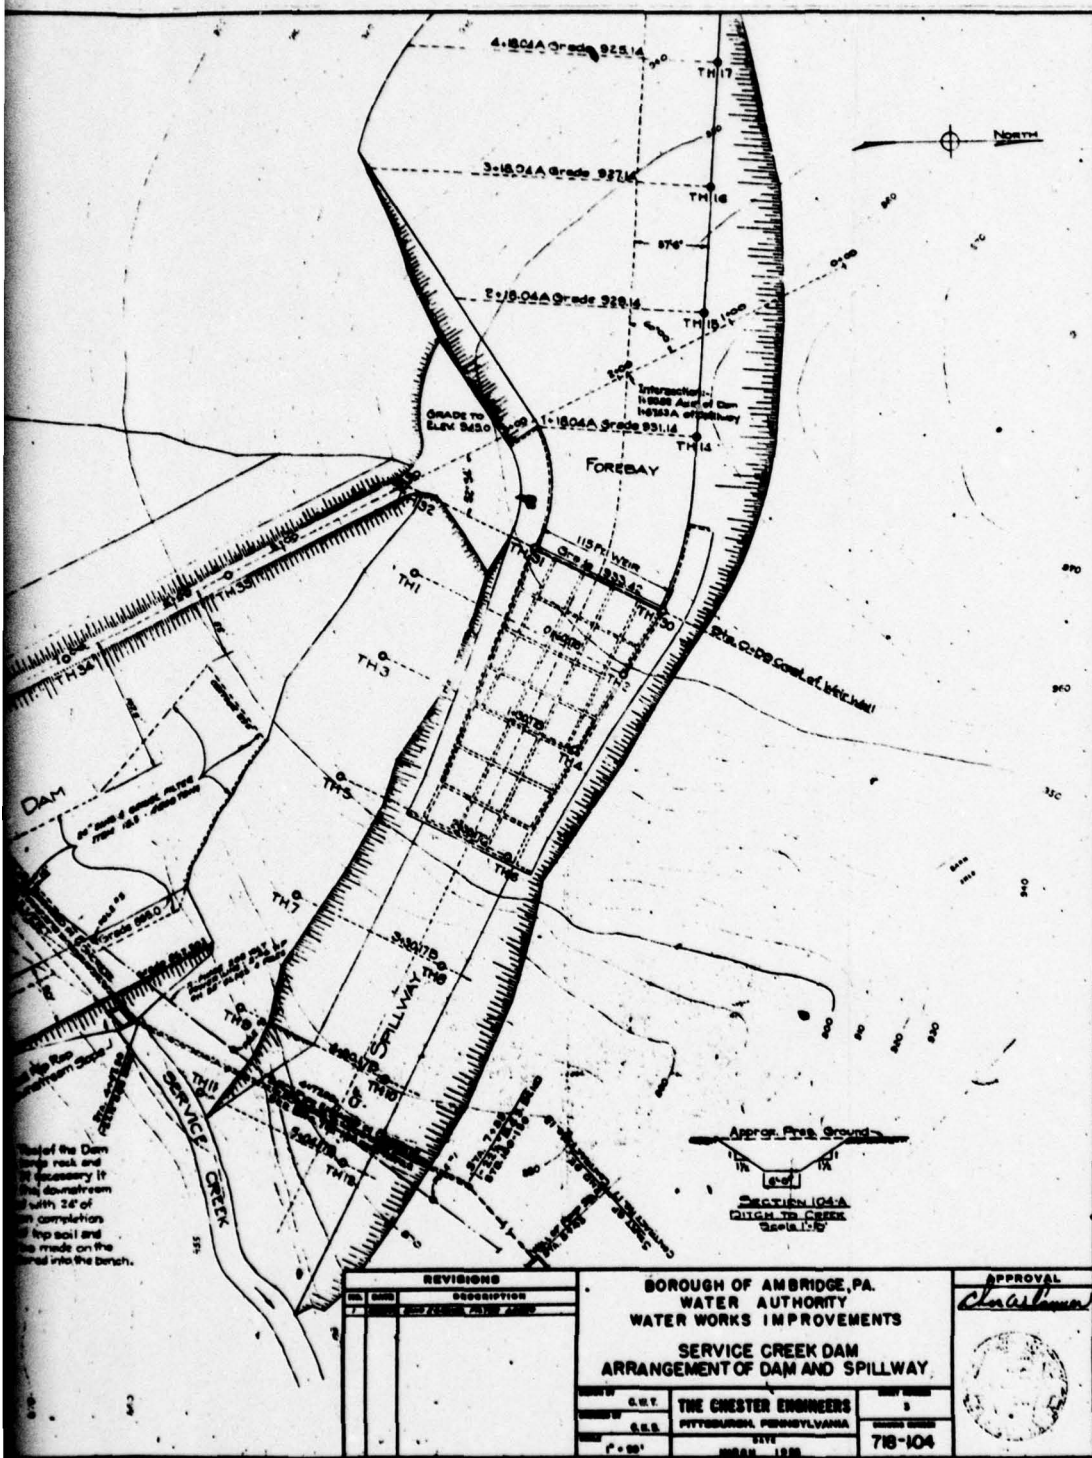
PLATE 2

- a. As designed, the dam (Plate 2) is a zoned embankment consisting of a central impervious core section with upstream and downstream shell sections (Plate 3). The internal drainage system for the embankment consists of a 2-foot-thick sand and gravel filter blanket beneath the downstream slope starting at a point about 100 feet downstream from the axis of the dam and terminating at the rock toe. The rock toe is located beneath a 50-foot-wide berm at a level about 25 feet above the downstream toe of the dam. The embankment materials were designated as Class A material for the impervious core section and Class B and Class C materials beneath the upstream and downstream slopes, respectively. These materials were described as follows: Class A - 50 percent clay and 50 percent soft shale; Class B - not less than 30 percent clay and the remainder shale; Class C - any material which is not classified as Class A or B. The embankment materials were

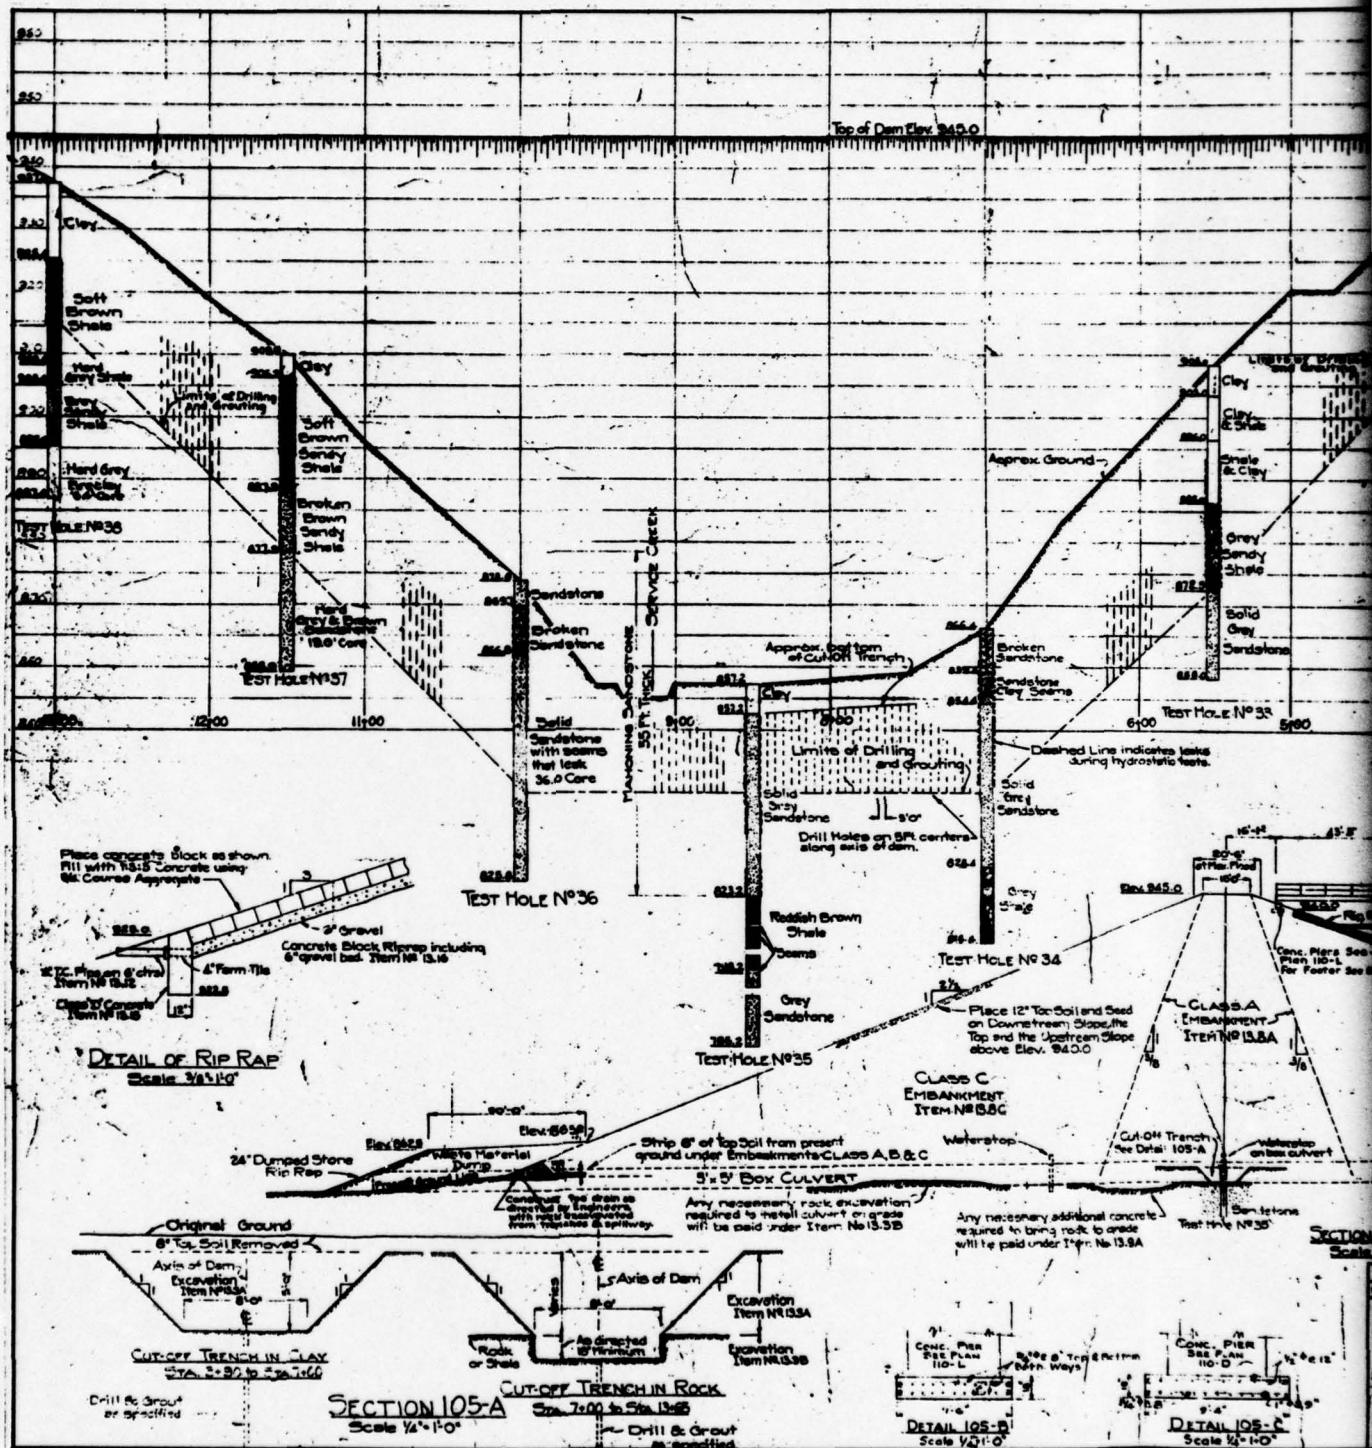
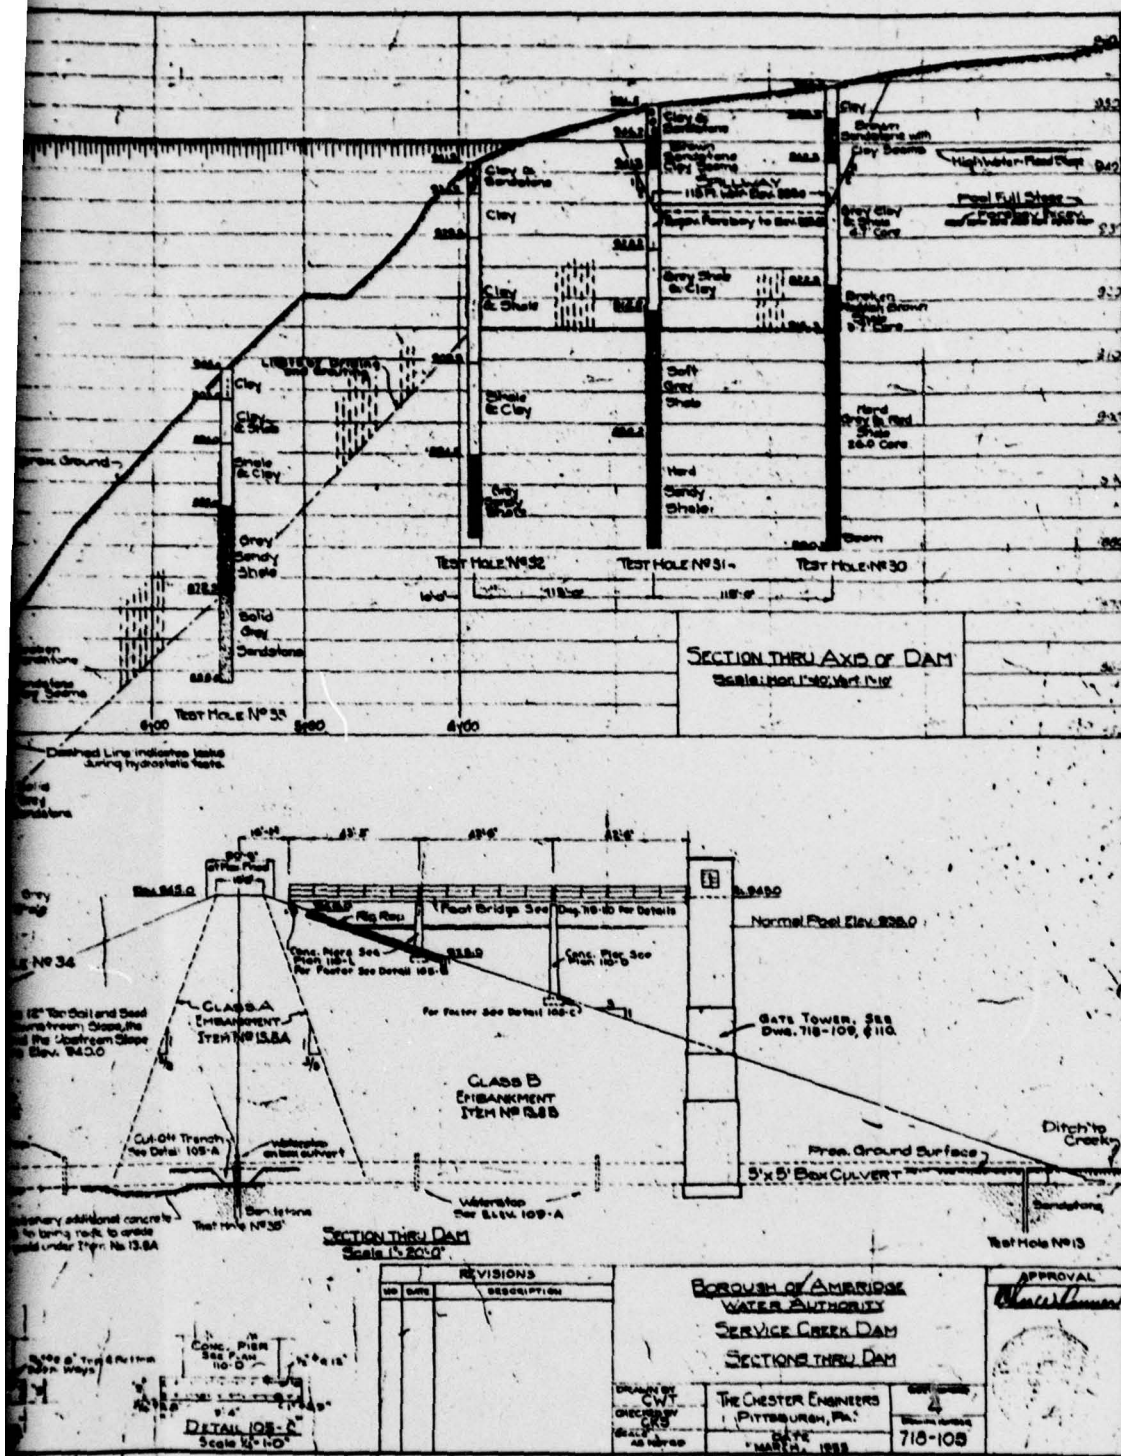
PLATE 3

- d. As indicated in Plate 3, the foundation of the dam was grouted through a single line of grout holes along the axis of the dam, extending from the right abutment through the embankment and the crest of the spillway. Grout holes were drilled 5 feet on centers and extended to a depth of approximately 20 feet at the valley floor and 30 feet on the abutments.
